**Move Out Inspection Form**

Tenant Name: YRC

Building/Suite: 53 Expo Road, Fishersville, VA 22939 Square Feet: 10,940

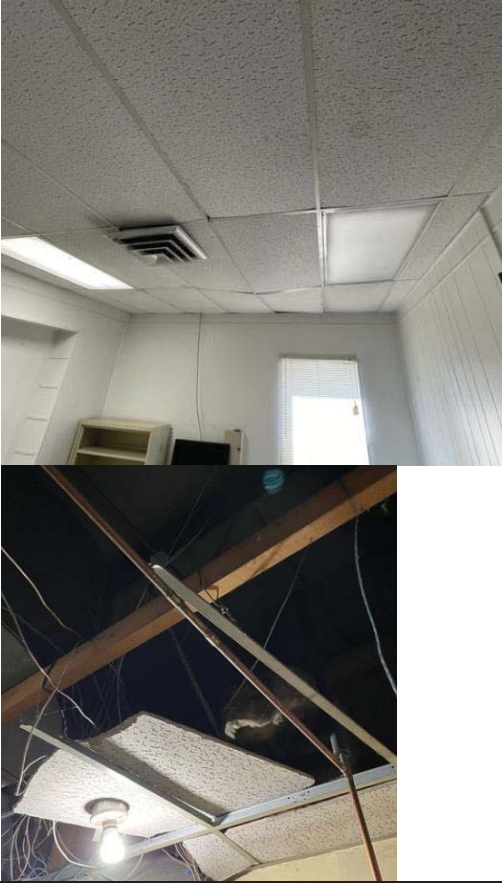
Voce Base	x			
Windows	x			
Window Covering		x		Several (4) blinds did not work throughout office
Doors and Hardware (Keys)		x		Did not have keys for interior offices
Door Closers	x			
Electrical Outlets	x			
Ceiling Grid		x		Damage in Service Center Mangers Office

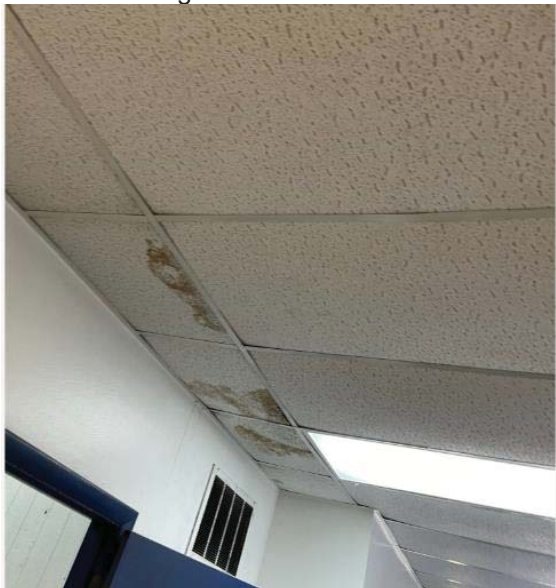
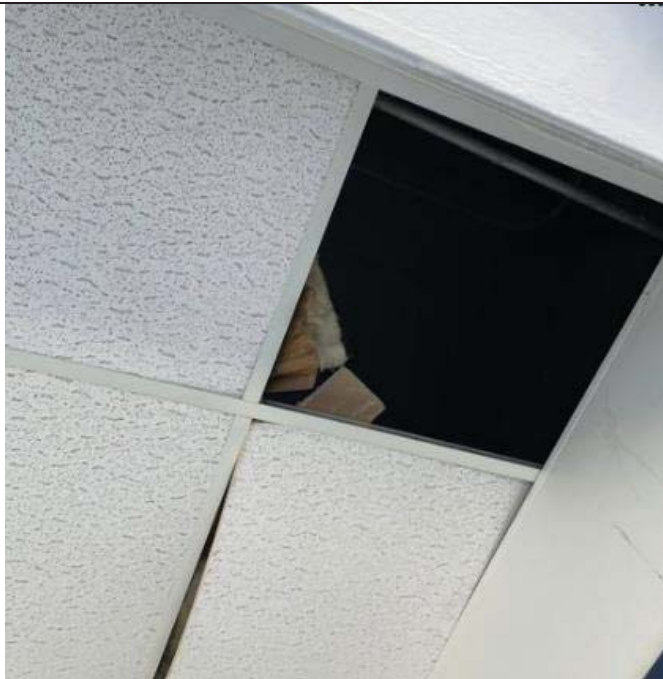
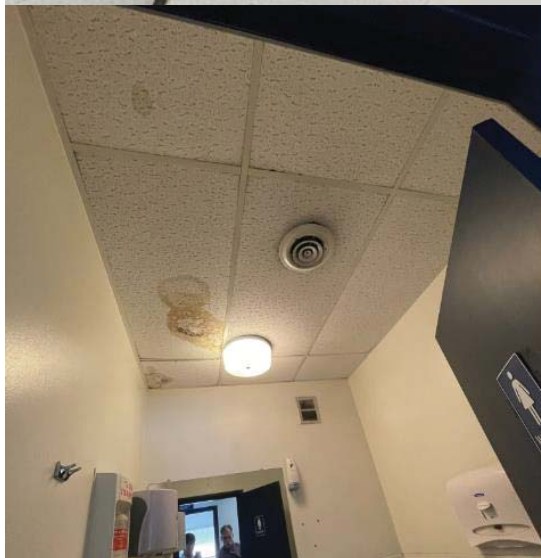
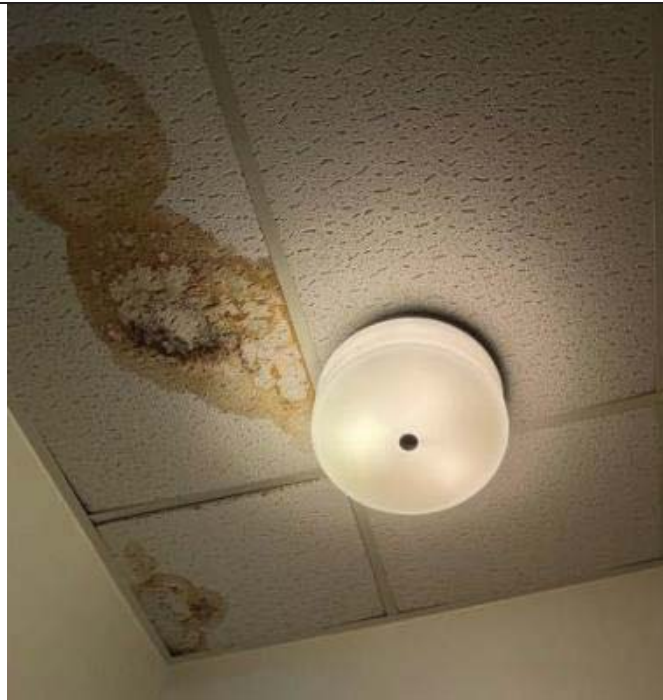
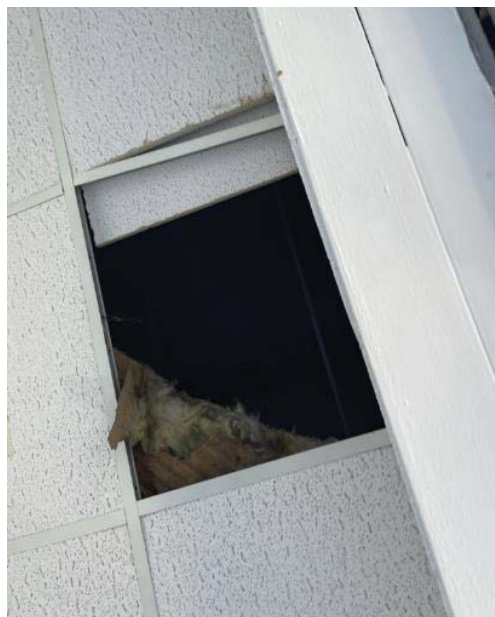
Ceiling Tiles		x		<p>8 stained ceiling tiles in main office and ladies' room</p>

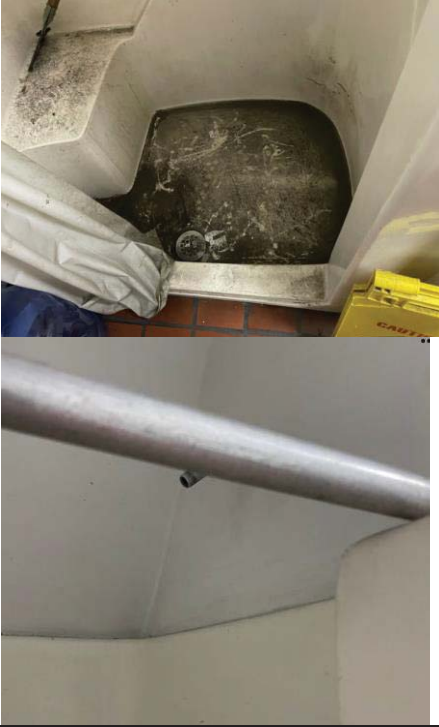
Partitions			x	
Walls		X		Walls damaged/dirty
Faucets		x		Faucet in men's rooms had no pressure and head missing from shower in WH restroom

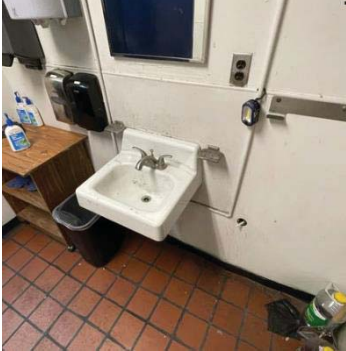
<p>Dirty</p>	
Lights	x				
Fans	x				
Water Heaters		x		<p>Tested water – ran warm but did not get hot. HWH appears to have a leak</p>

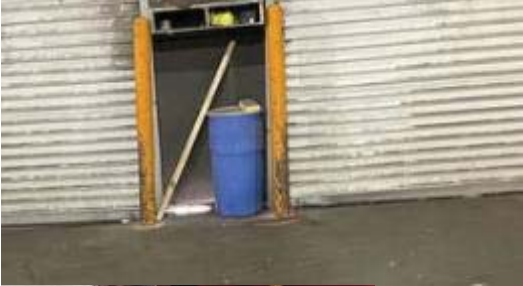
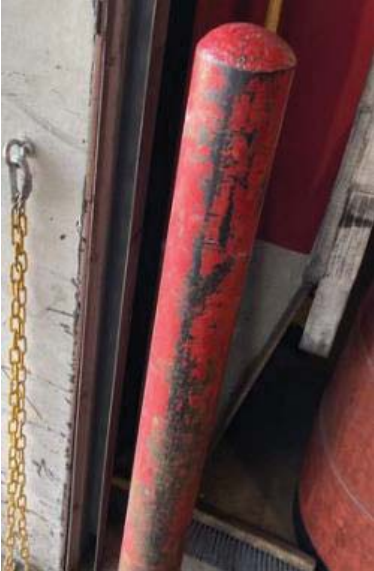
Acceptable	Not Acceptable	N/A	Notes
Warehouse				
Bollards		X		<p>All bollards need to be repainted</p>

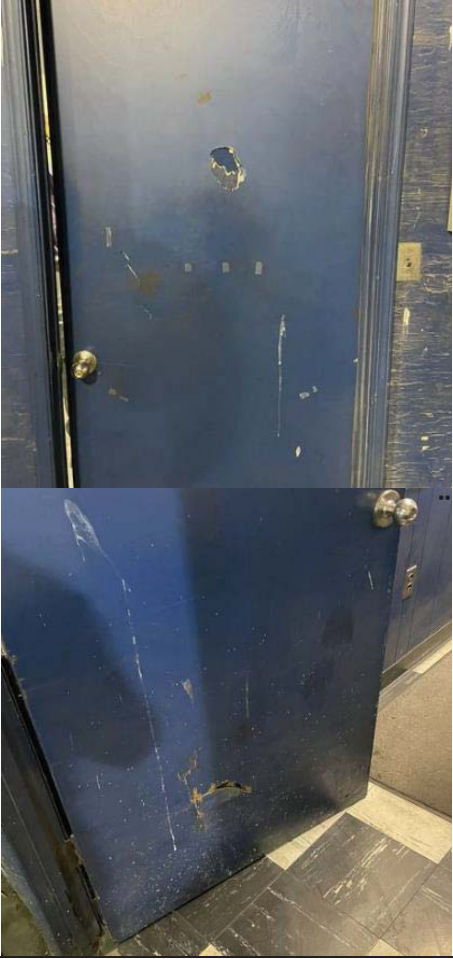
Floor joints		x		 	
Drains			x		
Demising Walls		x		Wall panel damage on rear (Eastern) wall	
Man Doors		x		Doors on North and South of WH have holes

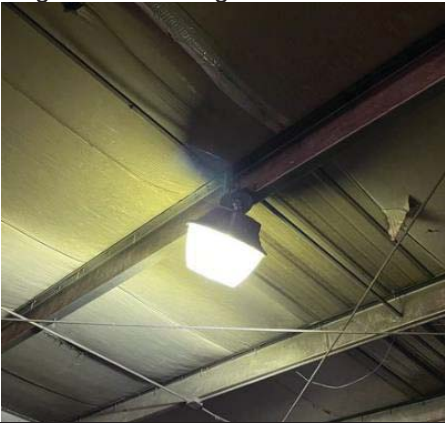
Lighting		x		4 lights not working. Overhead Door #18 light is bent

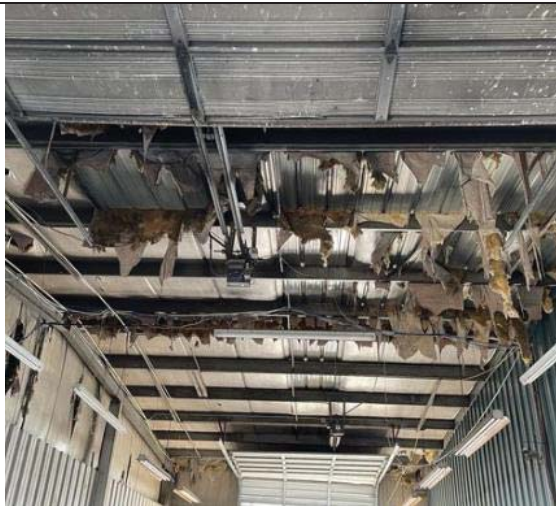
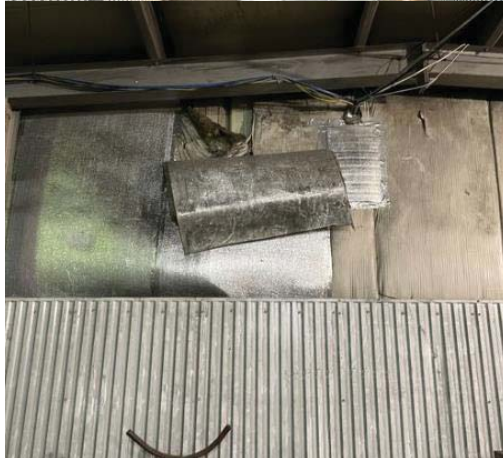
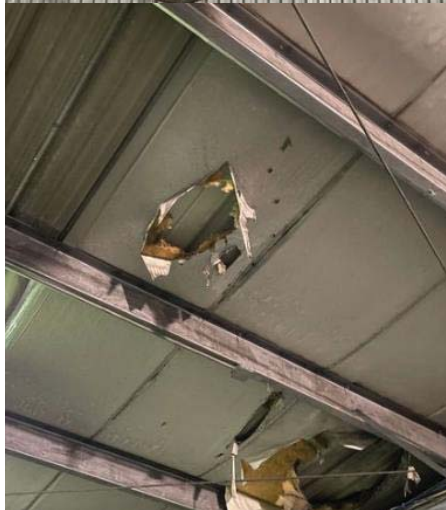
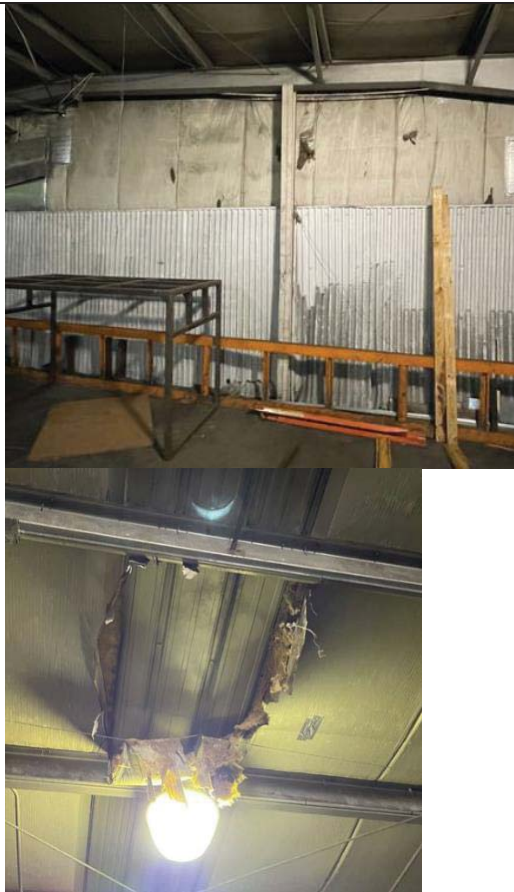
Breaker Panels	x				
Transformers			x		
Columns	x				
Bollards	x				
Other		x		Ceiling had insulation damage throughout WH

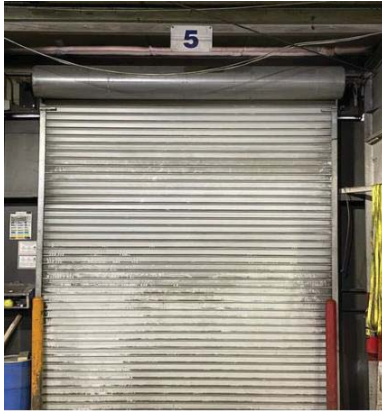
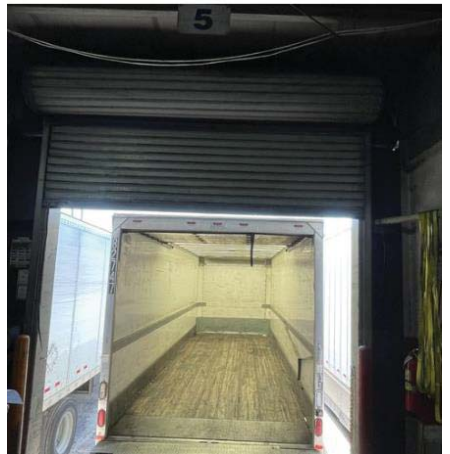
Dock Door #4		x		<div data-bbox="1084 310 1482 745" data-label="Image"> </div> <div data-bbox="695 722 1084 756" data-label="Text"> <p>Door casing damage on left side</p> </div> <div data-bbox="695 751 1157 1369" data-label="Image"> </div> <div data-bbox="695 1396 1073 1896" data-label="Image"> </div>
Dock Door #5		x		Door only opened partially. Dents in lower panels

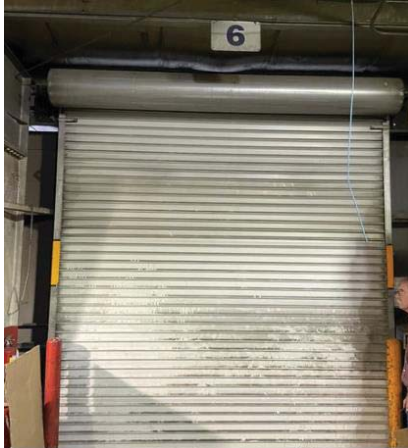
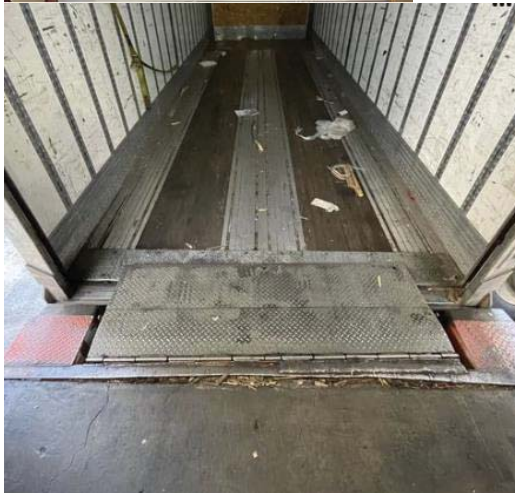
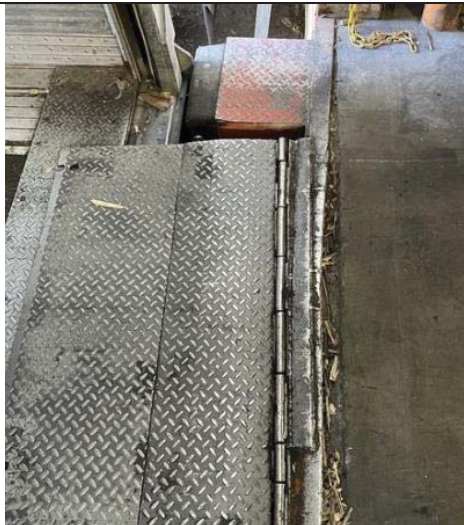
Dock Door #6		x		<p>Leveler pulled away from slab</p>

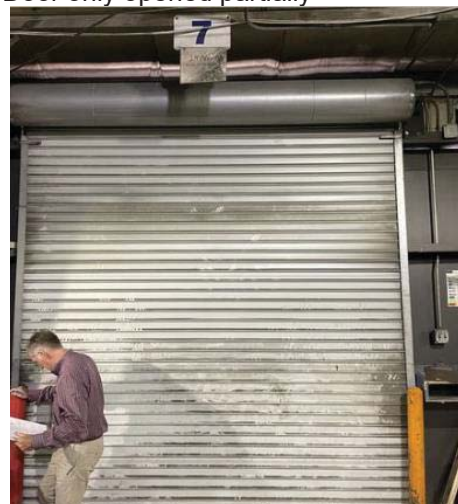
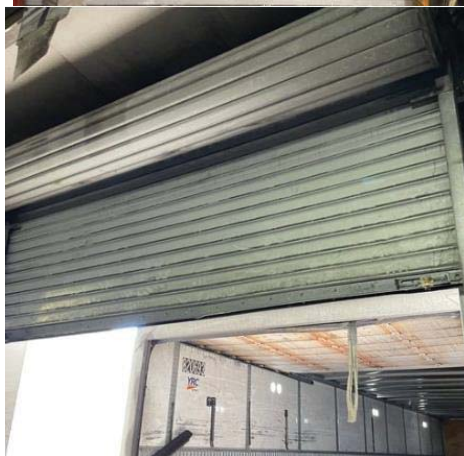
Dock Door #7		x		<div>Door only opened partially</div>

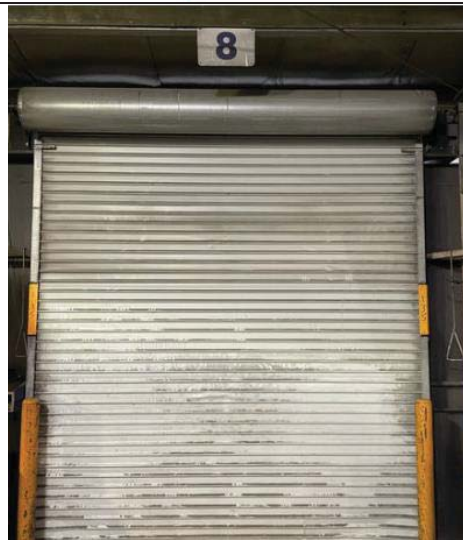
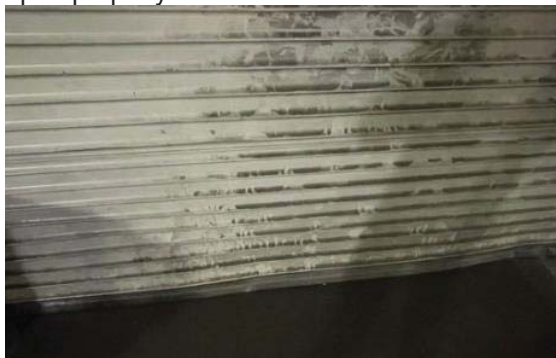
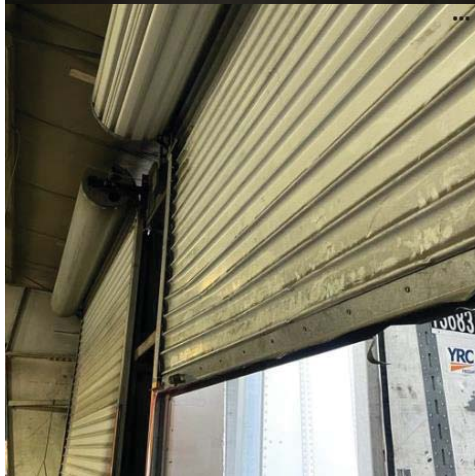
Dock Door #8		x		Bent rail (steel piece of bottom or door) on bottom of door, did not

open properly

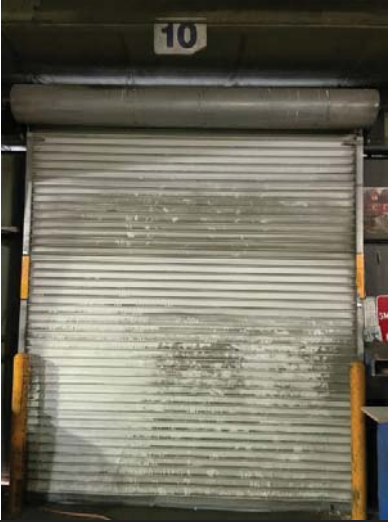
Dock Door #10		x		Bent rail (steel piece of bottom or door) on bottom of door

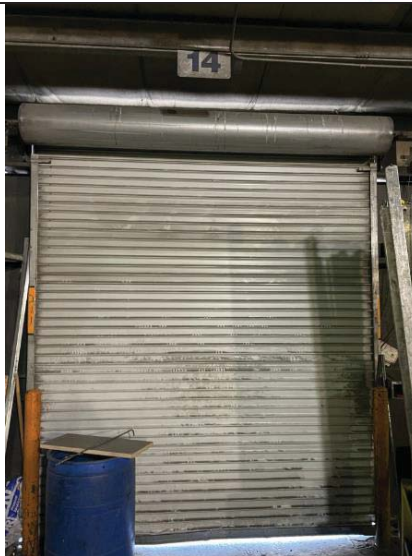
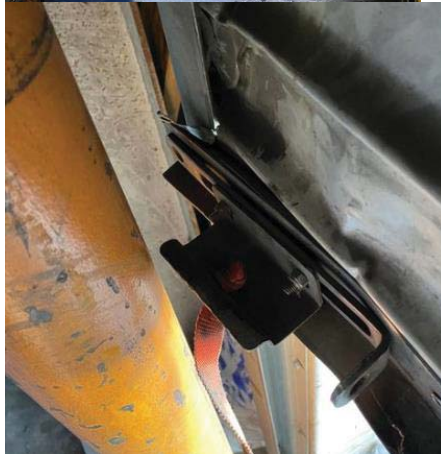
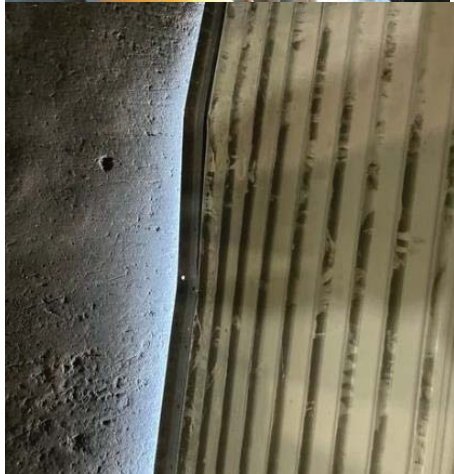
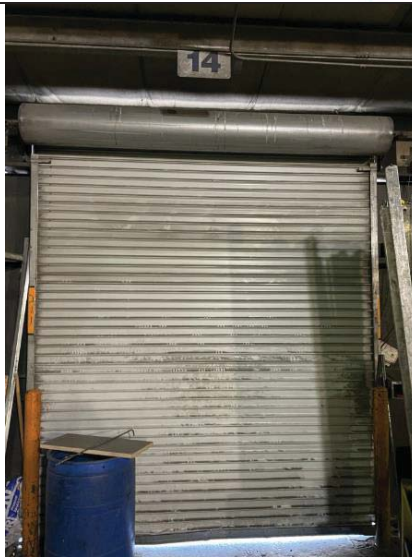
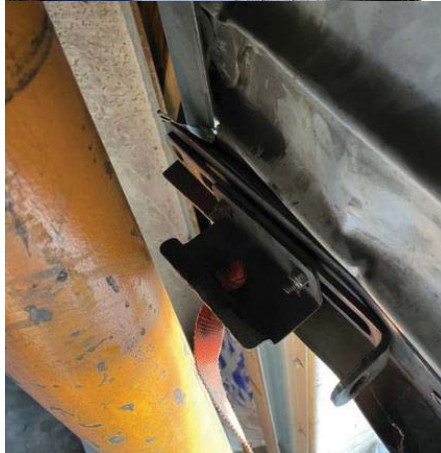
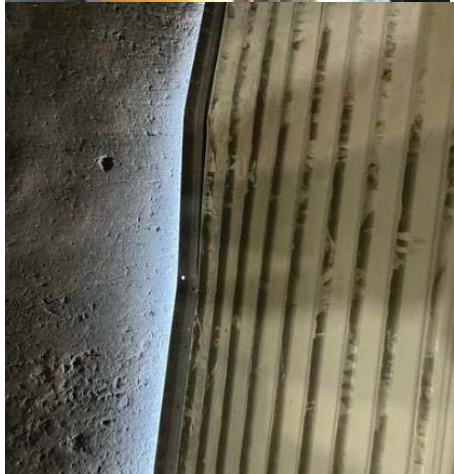
<p>opened partially</p>    
Dock Door #13	x			
Dock Door #14		x		Bent rail (steel piece of bottom of door) on bottom of door. Lock broken. Door did not open properly

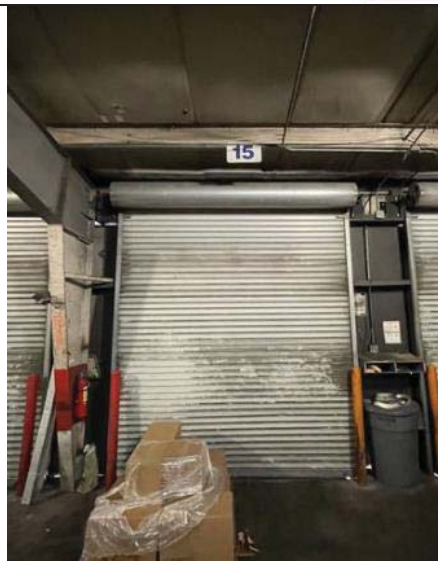
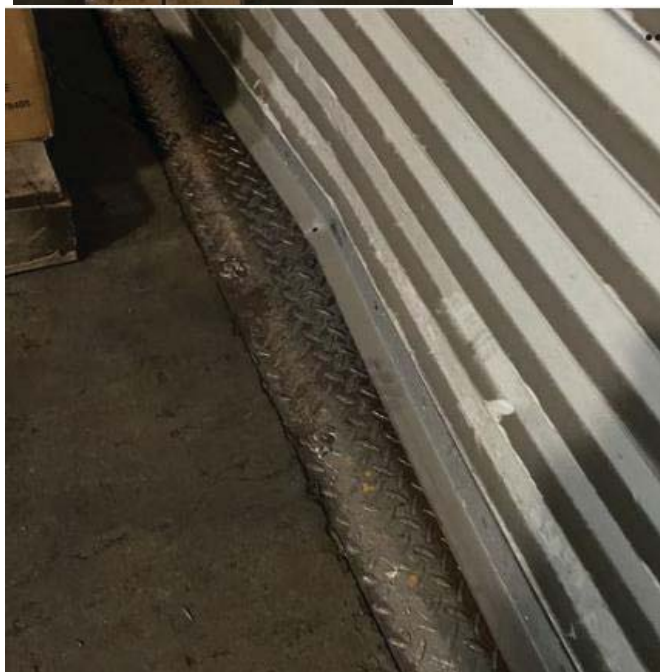
Dock Door #15		x		Lower panel badly bent. Door only opened partially.

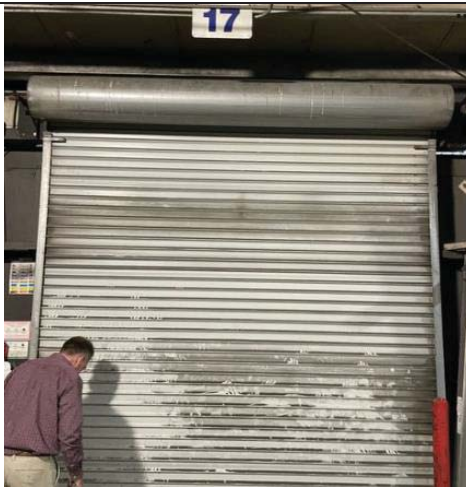
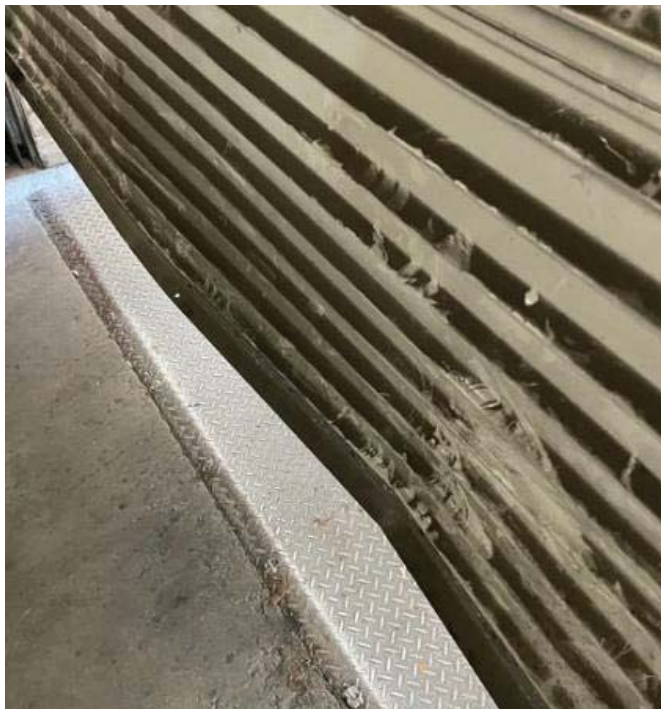
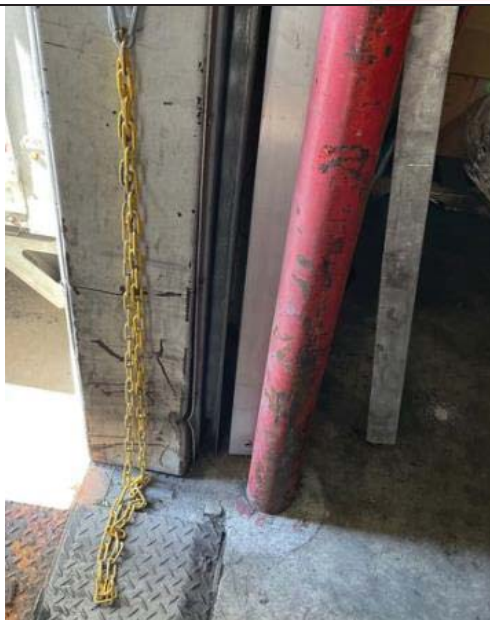
Dock Door #16	x			
Dock Door #17		x		Bent rail (steel piece of bottom of door) on bottom of door. Track damaged. Door casing on right side damaged

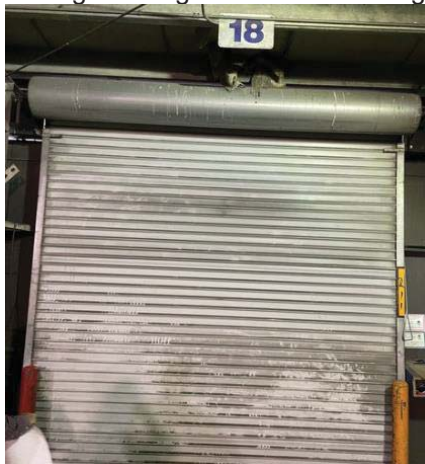
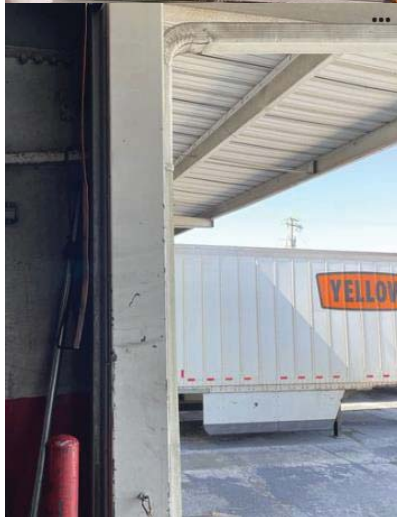
Dock Door #18

Bent rail (steel piece of bottom of door) on bottom of door. Track damaged on right side. Door casing on bottom right side damaged.

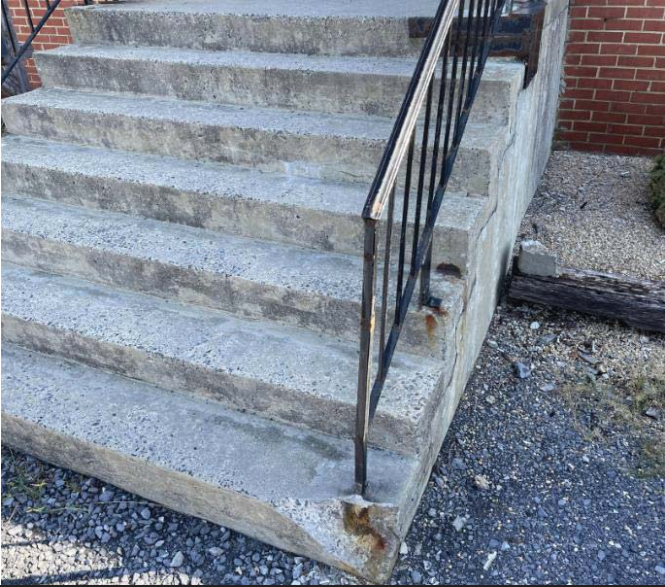
Fire Protection			
Sprinkler Heads			x
Risers			x
Fire Pump			x
Fire Extinguishers	x		Serviced in June 2023
Exterior			
Steps/Handrails		x	Concrete damage on steps to main entrance

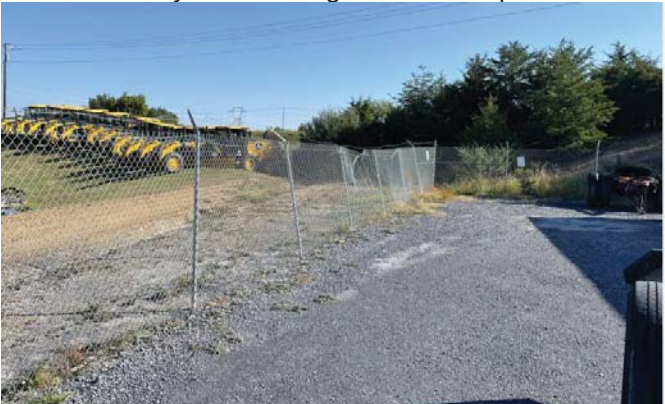
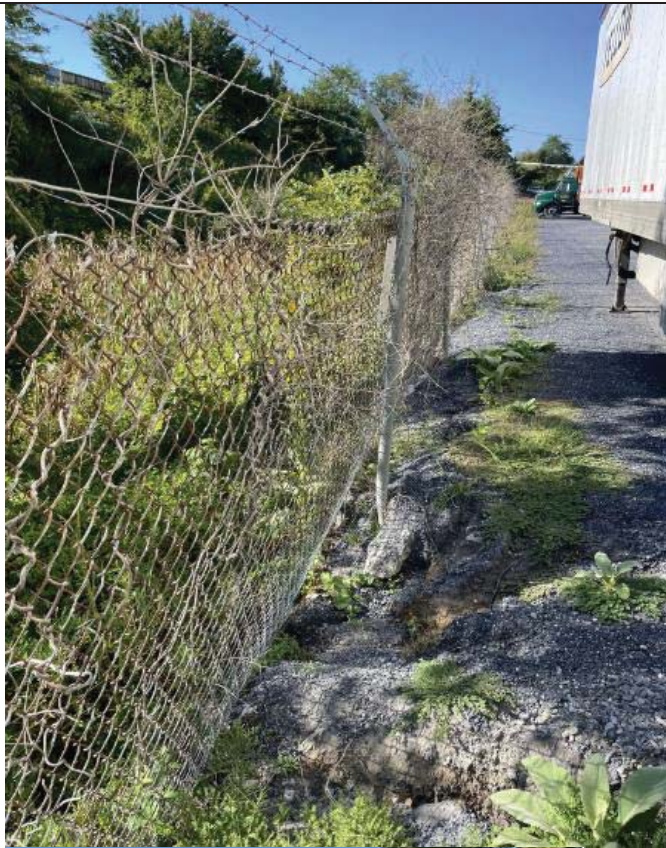
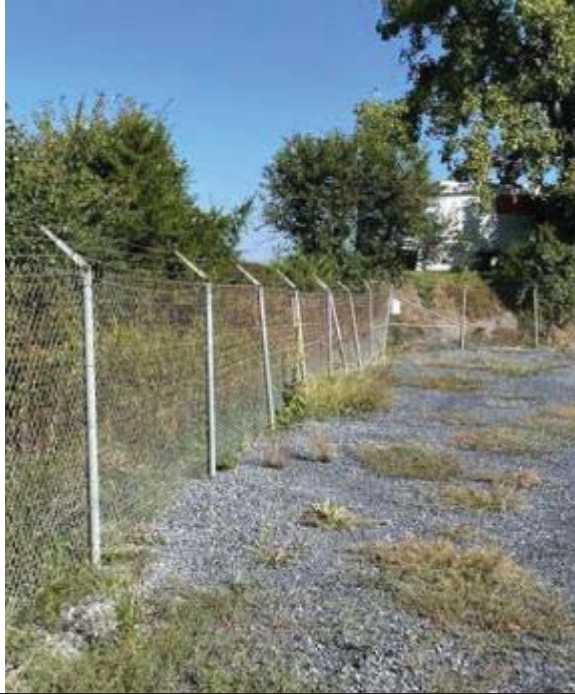
Guard Rails		x	Fence around yard is damaged in several places

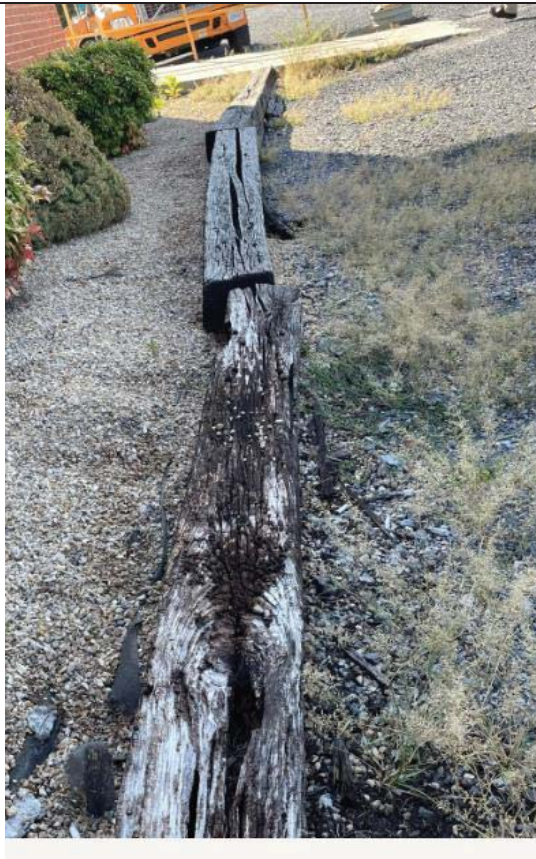
Pipe Bollards	x			
Ramps	x			
Parking Stops		X		Deteriorated need to be replaced

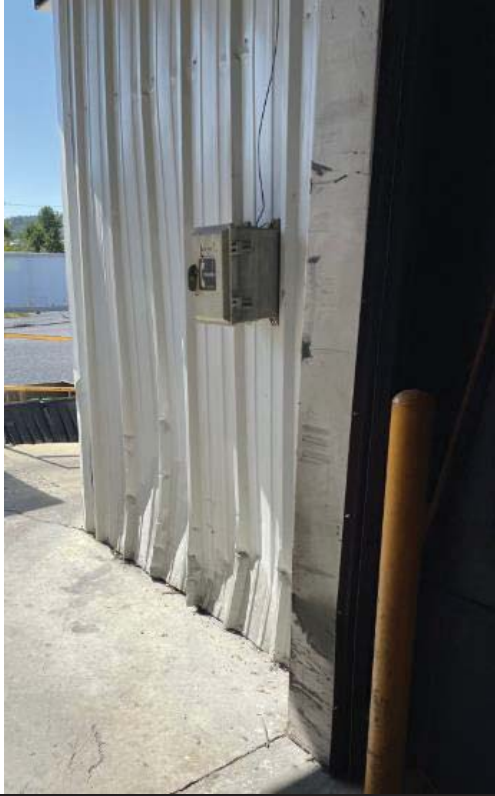
Yard		x	Gravel "yard" has erosion on north side
Exterior Siding		X	Badly damaged in many areas.

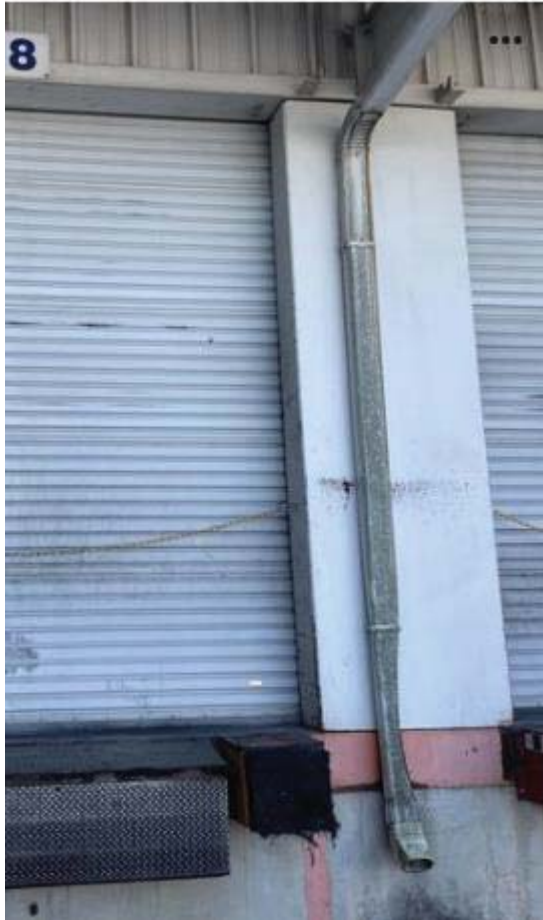
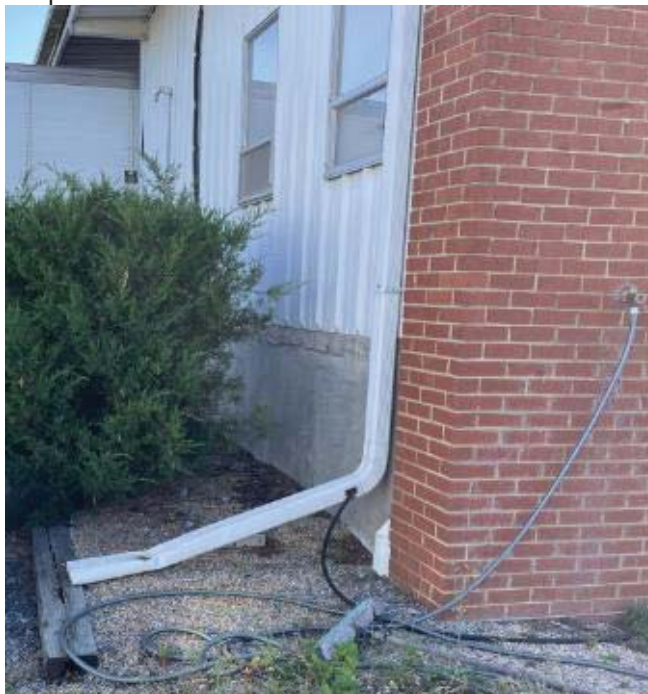
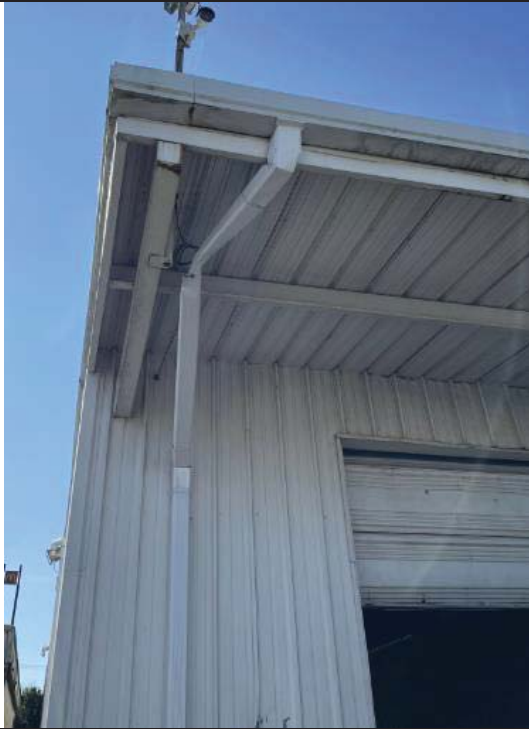
Specialty Items					
"Trucker Break Room"		x		Shower filthy and head missing from faucet. Room needs to be deep cleaned	
Exterior Lighting			x	Unable to properly check	
Down Spouts		X		1 crushed on south side of building. 2 Damaged at drive in doors to

shop

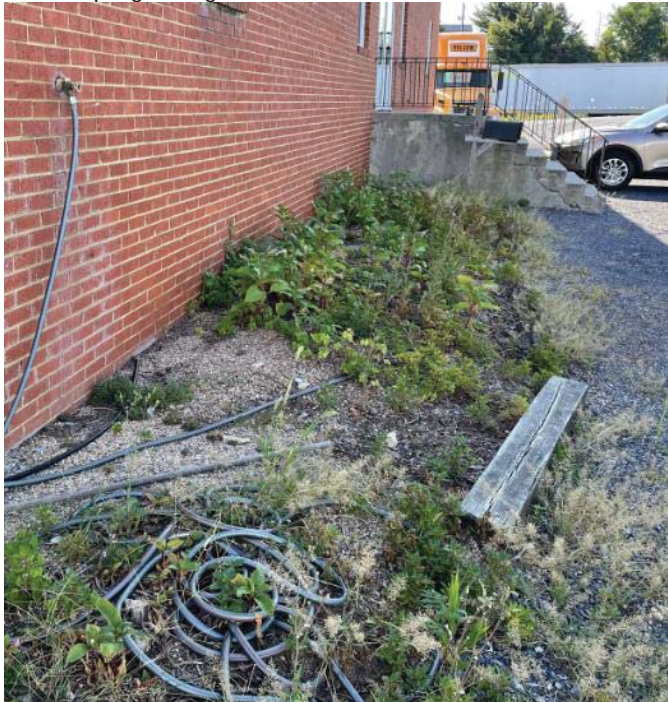
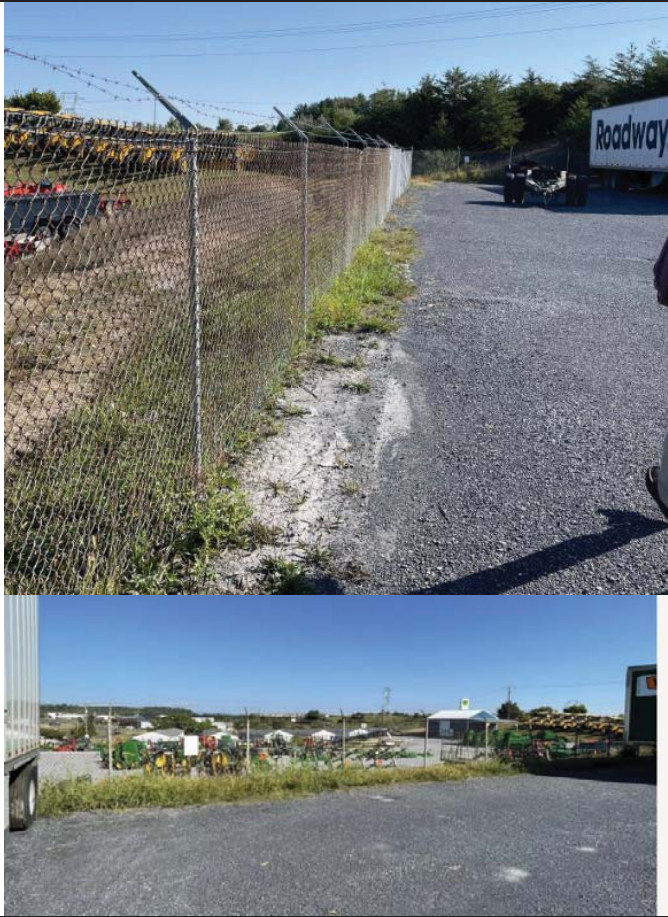
Grounds		X		<p>Vegetation growing on fence around perimeter of property. Entrance landscaping overgrown with weeds</p>

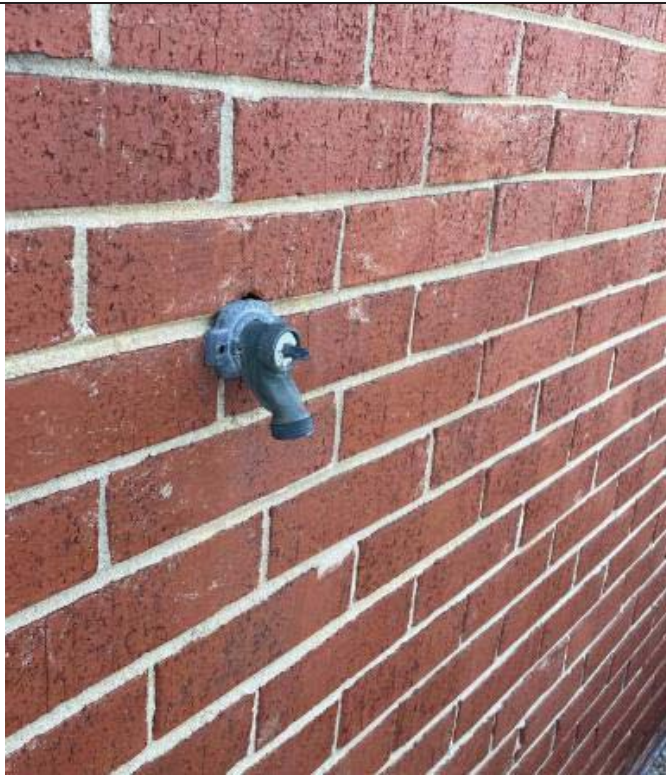
Exterior Spigot		X		Located on front of building to the right of the entrance. Missing handle

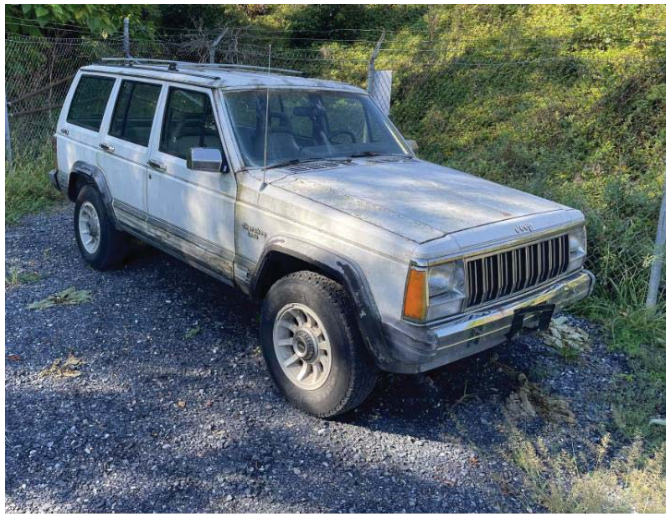
To be removed from premises. Located on southwestern corner.

Needs to be removed and all electrical capped properly

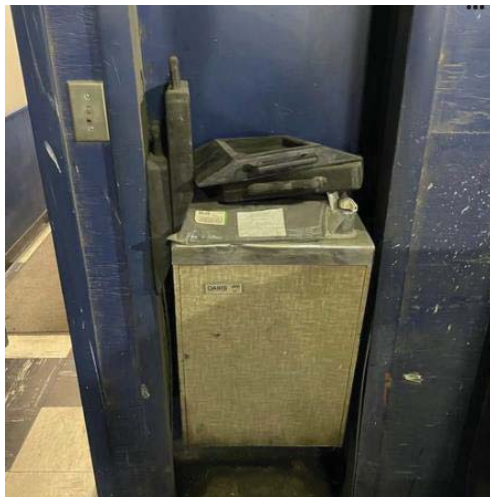
Water Cooler

Water fountain in warehouse does not work. Needs to be replaced.

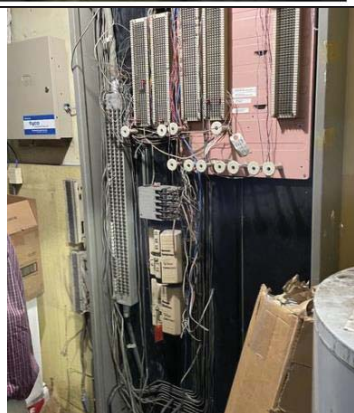
Telco Closet

Very Dirty.
